**TRANSPORTATION SCIENCES
CRASH DATA RESEARCH CENTER**

Veridian Engineering
Calspan Operations
Buffalo, New York 14225

**CALSPAN ON-SITE AIR BAG RELATED CHILD FATALITY INVESTIGATION
CALSPAN CASE NO. CA96-010
VEHICLE - 1996 DODGE CARAVAN SE
LOCATION - TENNESSEE
CRASH DATE - 1996**

Contract No. DTNH22-94-07058

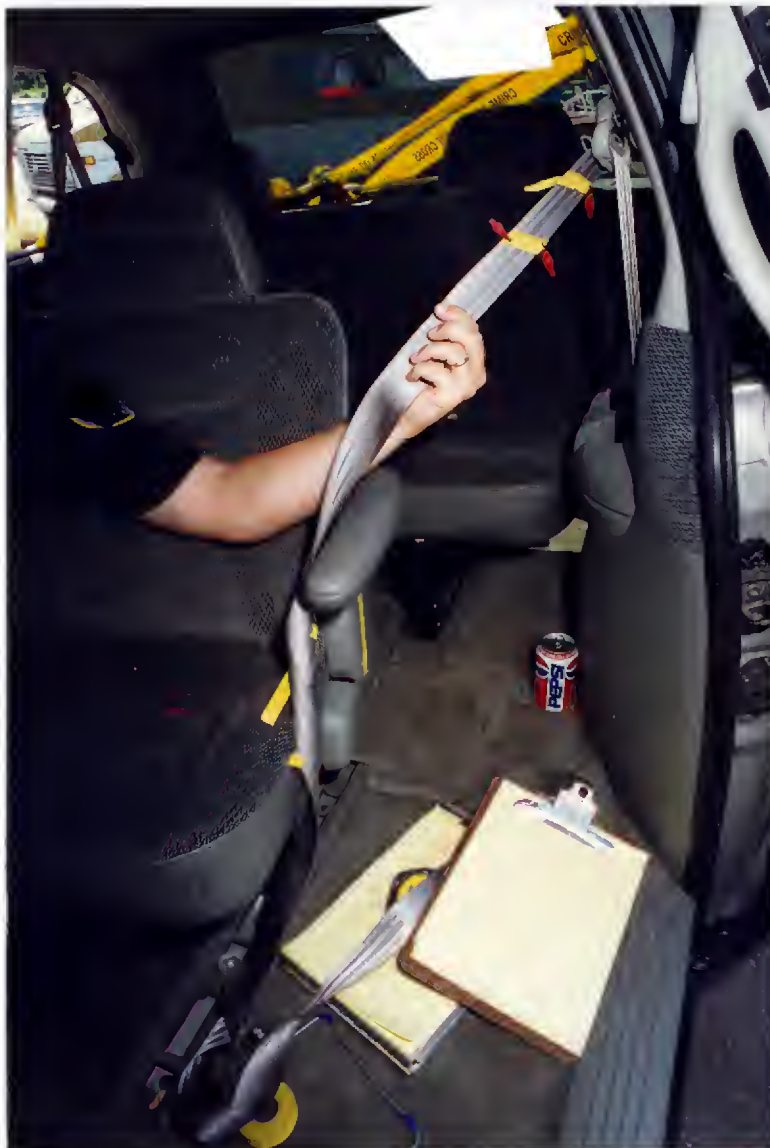
99. View of a contact to the left front seat back.

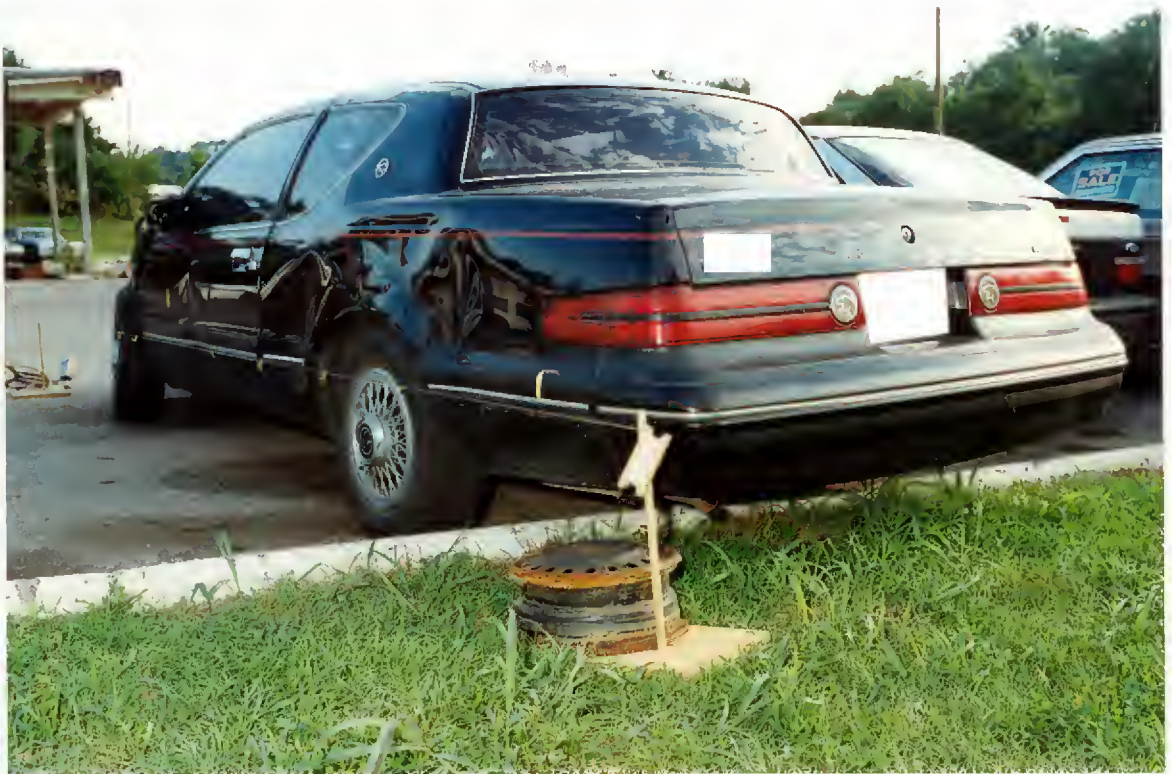
112. Left side view of the secondary (side slap) damage.
